Manhole Inspection Summary

Manhole # S53C__012MH

Insp Date: **6/12/08 9:16 AM**

Location Address: **rear 124 n clinton st**

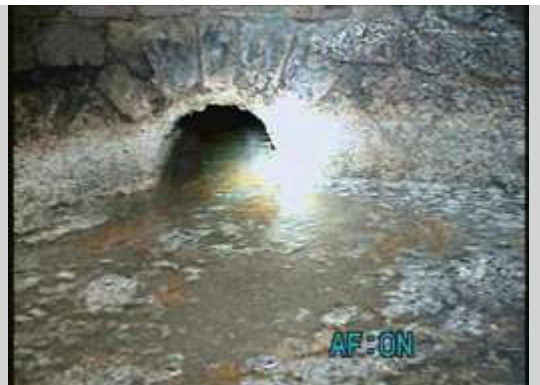
12 O'Clock Outflow

8 in. Circular Gravity Sewer
Pipe Out @ 12 O'Clock

Infiltration: **None** Pipe Seal Cond: **Sound**
